**LIMITED ASBESTOS INSPECTION REPORT**

HORRY GEORGETOWN TECHNICAL COLLEGE CONWAY CAMPUS 200 BUILDING

Asbestos Inspections, LLC Project # 2026-01-092

**Inspection Completed On** – March 4, 2026  
**Report Prepared On** – March 13, 2026

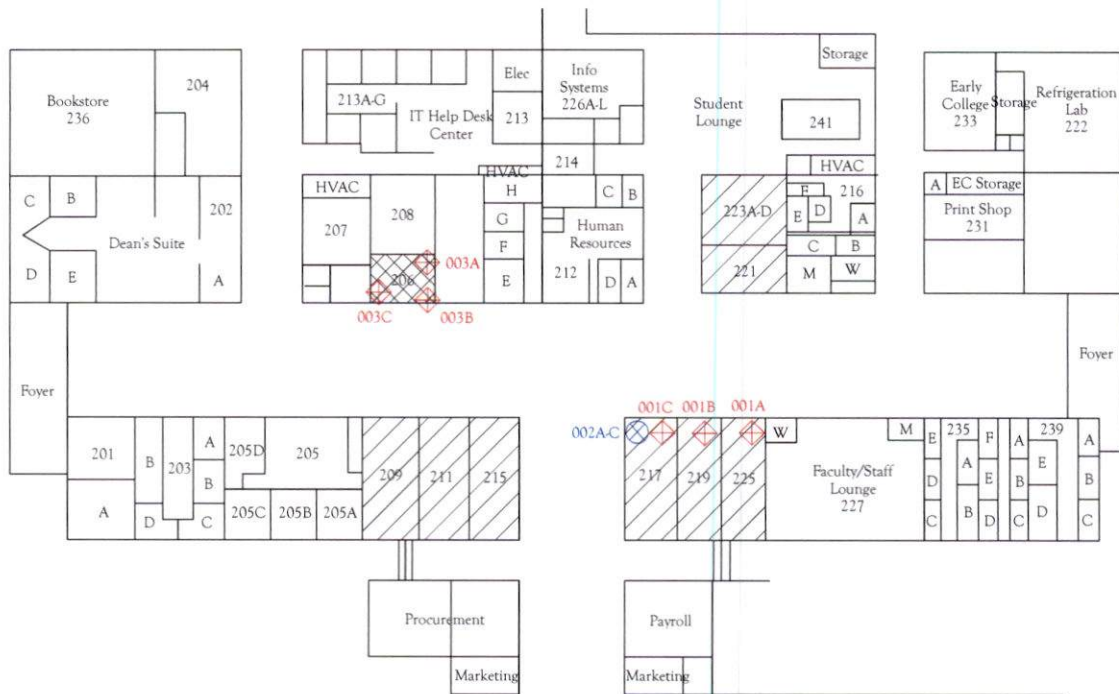
**Figure 2**

▨ Asbestos containing floor tile and mastic - Approx. 5245 sq. ft.

▩ Asbestos containing carpet mastic in Room 206 - Approx. 792 sq. ft.
